NATIONAL TRANSPORTATION SAFETY BOARD

SYSTEMS GROUP CHAIRMAN'S FACTUAL REPORT

DCA13MA120

Location: San Francisco, CA
Date: July 6, 2013
Time: 11:28 PDT
Aircraft: Boeing 777-200ER

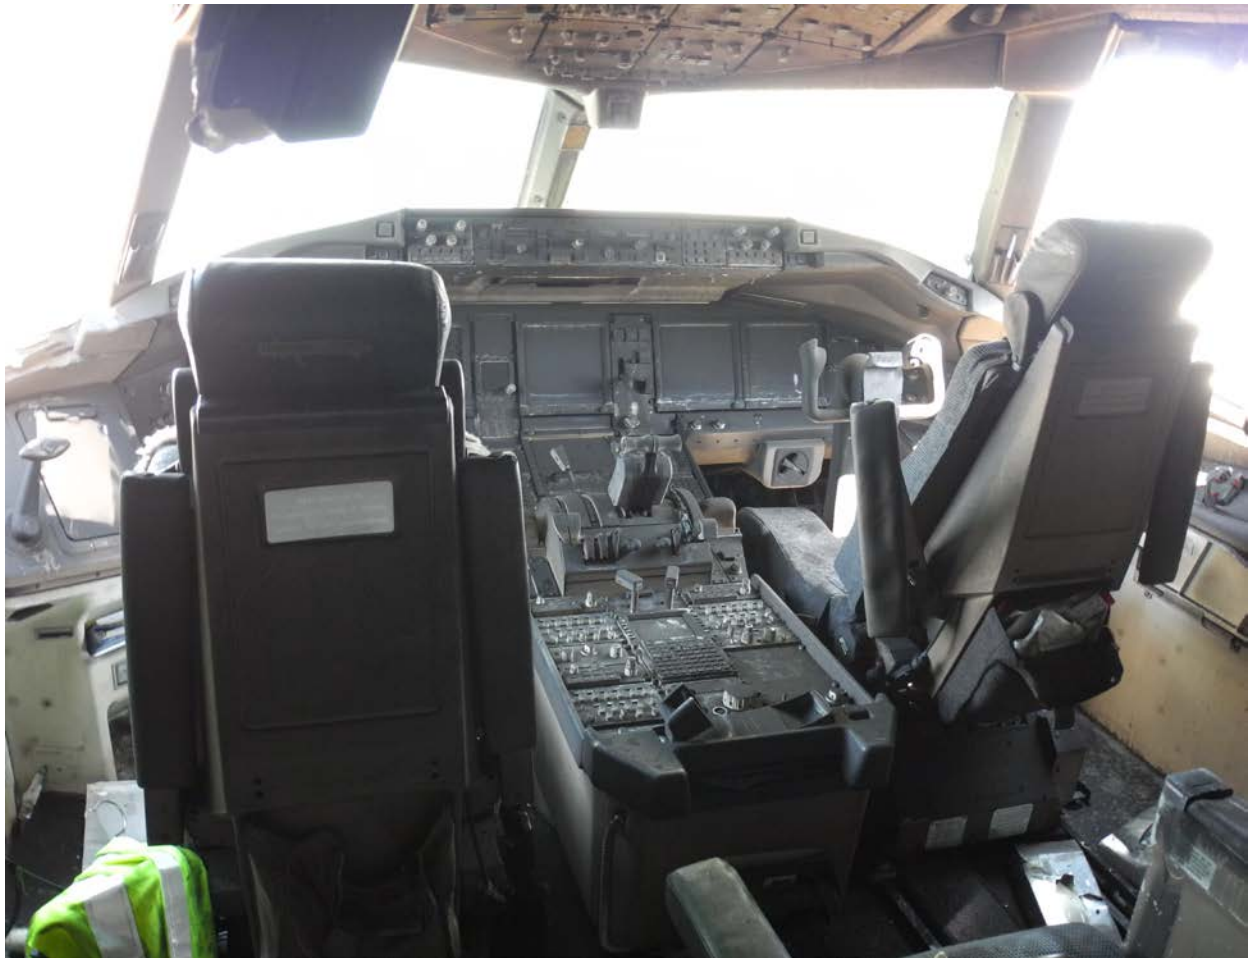
Figure 1: Flight Deck

The flight deck was heavily sooted but generally did not exhibit thermal damage (see Figure 1). The Captain's and First Officer's rudder pedals appeared in a neutral position and moved together normally when either pedal set was moved. The tiller on both sides also moved when the pedal positions changed. The control yokes and columns demonstrated continuity and moved together normally when either side was moved. Head-up display systems were not installed on the aircraft.

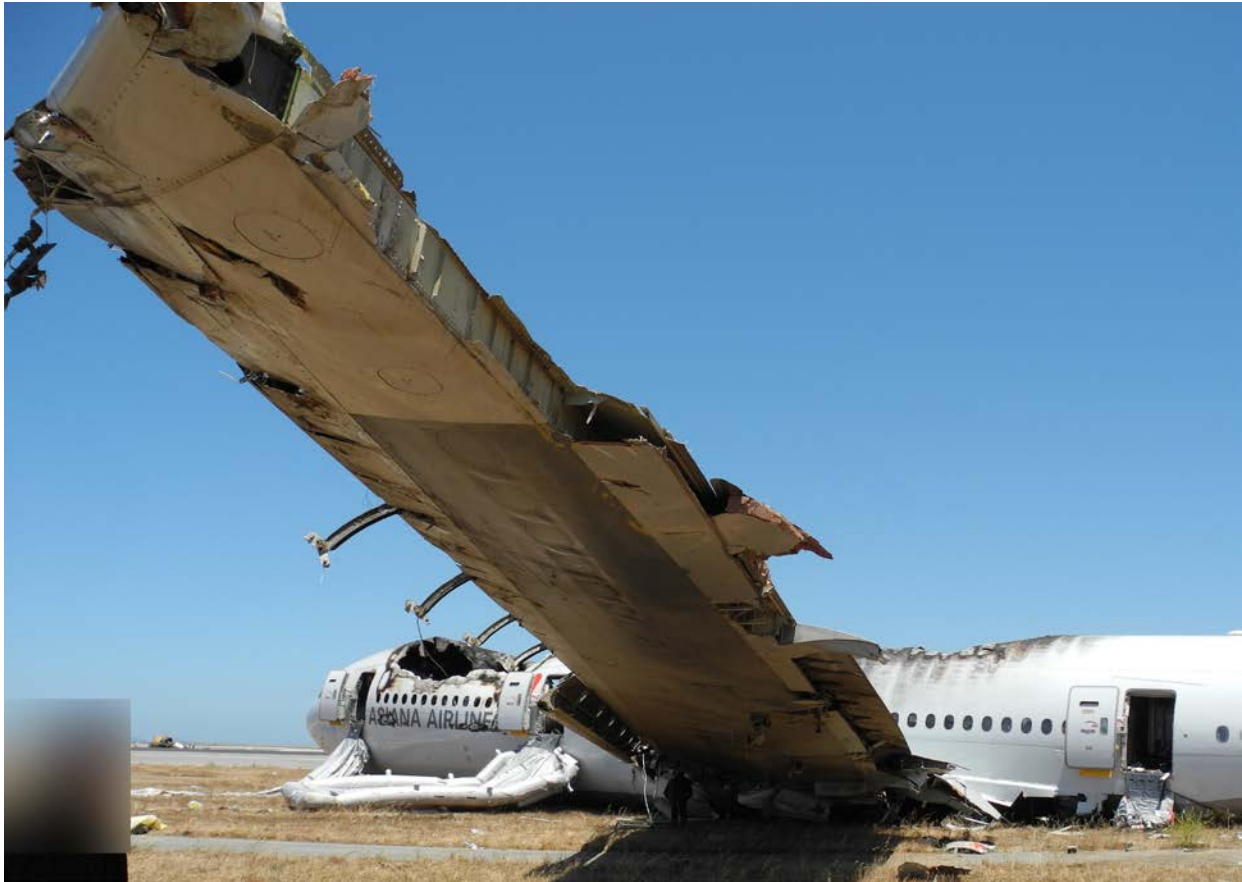
Figure 2: Left Wing

The left wing Krueger flap linkage arm was fractured. The surface was found in the extended position.

The left wing inboard flap outboard transmission assembly ballscrew and ballnut remained on the aircraft but were separated from the rest of the transmission assembly. The ballscrew measured 22.25 inches from the ballnut to the transmission interface. This measurement corresponded to a

On the left wing, the three outboard slat surfaces (slats 1, 2, and 3) were separated from the wing structure with all drive mechanisms still attached to the wing except for the outboard drive mechanism for slat 1. This drive mechanism was separated from the wing and remained attached to the slat. Slats 4, 5, and 6 remained attached to the wing, were in line, and visually appeared to be in the gapped position.

The left wing aileron power control units (PCUs) were attached to the wing, but the control surface was damaged and only small portions of the surface were still attached to the PCUs. The underwing access panels were removed, and the PCUs were examined. In general, each of the compartments was clean with no foreign objects noted, and all wiring and hydraulic lines were intact and connected. The left aileron inboard and outboard actuator chrome extensions measured approximately 2.5 inches from the piston housing to the attachment pin. These measurements corresponded to a surface position of approximately 7.6 degrees trailing edge down.

For the left wing, the flaperon surface was broken and both actuators remained attached to the wing and broken surface. For the inboard actuator, the chrome extension from the housing to the attachment pin measured 13.5 inches. This measurement corresponded to a surface position of approximately 24 degrees. For a flaps lever setting in the 30 detent, the corresponding flaperon full droop surface position is 31 degrees.

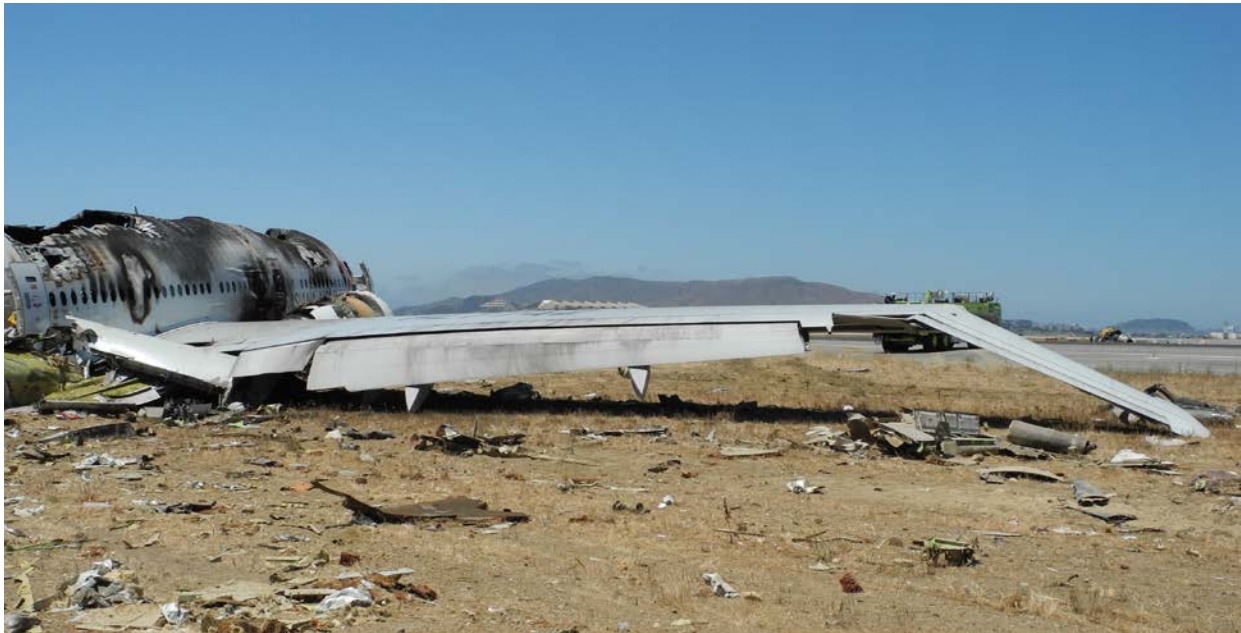
Figure 3: Right Wing

The Krueger Flap was attached and the drive mechanism was intact. The surface appeared to be in the extended position.

The right wing inboard flap was severely damaged. The right wing inboard flap outboard transmission assembly ballscrew measured approximately 25 inches from the ballnut to the transmission interface. This was an expected measurement for a flap lever placed in the 30 degree detent. The right wing inboard flap inboard transmission assembly ballscrew measured approximately 25.5 inches from the ballnut to the transmission interface. This measurement was taken after the aircraft was moved to a recovery location. This was an expected measurement for a flap lever placed in the 30 degree detent.

All right wing slats remained attached to the wing and appeared to be in line. The drive extensions from the wing skin to the closest bolt were measured for the inboard and outboard drives for each slat. All slat drive measurements corresponded to the slat surfaces being in the gapped position (see Figure 4).

The right wing aileron power control units were attached to the wing and the control surface. The aileron surface was broken into two pieces at the location where the wing was bent downwards. The underwing access panels were removed, and the PCUs were examined. In general, each of the compartments was clean with no foreign objects noted, and all wiring and hydraulic lines were intact and connected. The right aileron inboard and outboard actuator chrome extensions measured approximately 3.5 inches from the piston housing to the attachment pin. These measurements corresponded to a surface position of approximately 12.2 degrees trailing edge up.

The flaperon remained attached to the wing but appeared to be in an overly retracted position. Flaperon actuator measurements were not taken because the PCUs were not accessible.

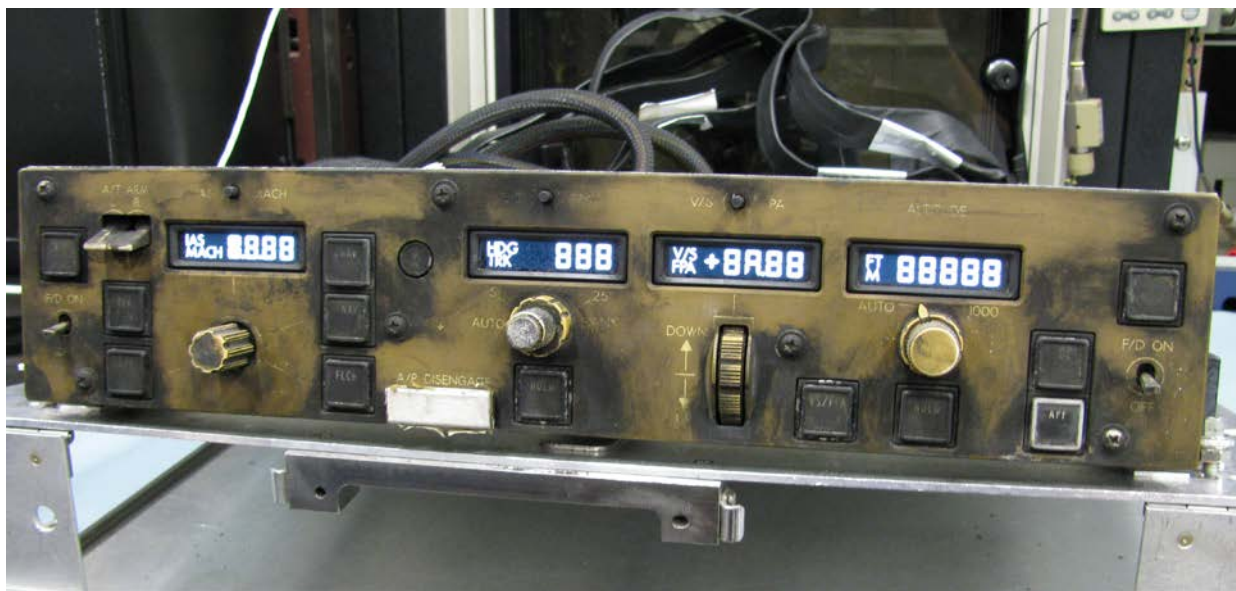
Figure 8: Mode Control Panel Connected to the Test Bench

The MCP was removed from a secure locker and removed from the packaging. A burnt odor was present from the unit. A visual inspection was performed and the unit appeared sooty on the front and top surfaces but was in good physical condition (see Figure 8). All cover screws were flush with the cover. The unit tamper seal located on the top of the unit was intact. The two test access tamper seals located at location J4 and J5 on the back of the unit were broken.

The unit passed all performed tests with the exception of test blocks 662100, 663700, 672100, and 673700. These four tests were considered failed because the bottom horizontal segment of the 100's digit in the Vertical Speed/Flight Path Angle LCD screen was missing. It was also noted during testing that the following push buttons would remain in the pressed position when pushed: left Autopilot, Autothrottle, Flight Level Change, Heading Hold, Vertical Speed/Flight Path Angle, Altitude Hold, Approach, right Autopilot, and Localizer. All push-button switches were heavily contaminated with soot. After brushing off some of the soot the switches were able to move more freely but still demonstrated hesitation.

After the functional test was completed the back cover was removed. The top of the circuit cards were coated in soot. A 3 inch long piece of foreign object debris that ranged from 0.25 inches to 0.5 inches wide and that resembled a thin piece of tape was found balled up and pushed against the end plate within the cooling chamber. Wiring connectors J1 and J2 on the motherboard and J10 and J11 on the rear interconnect card were disconnected and the front panel was removed to gain visual access to the switch housings.

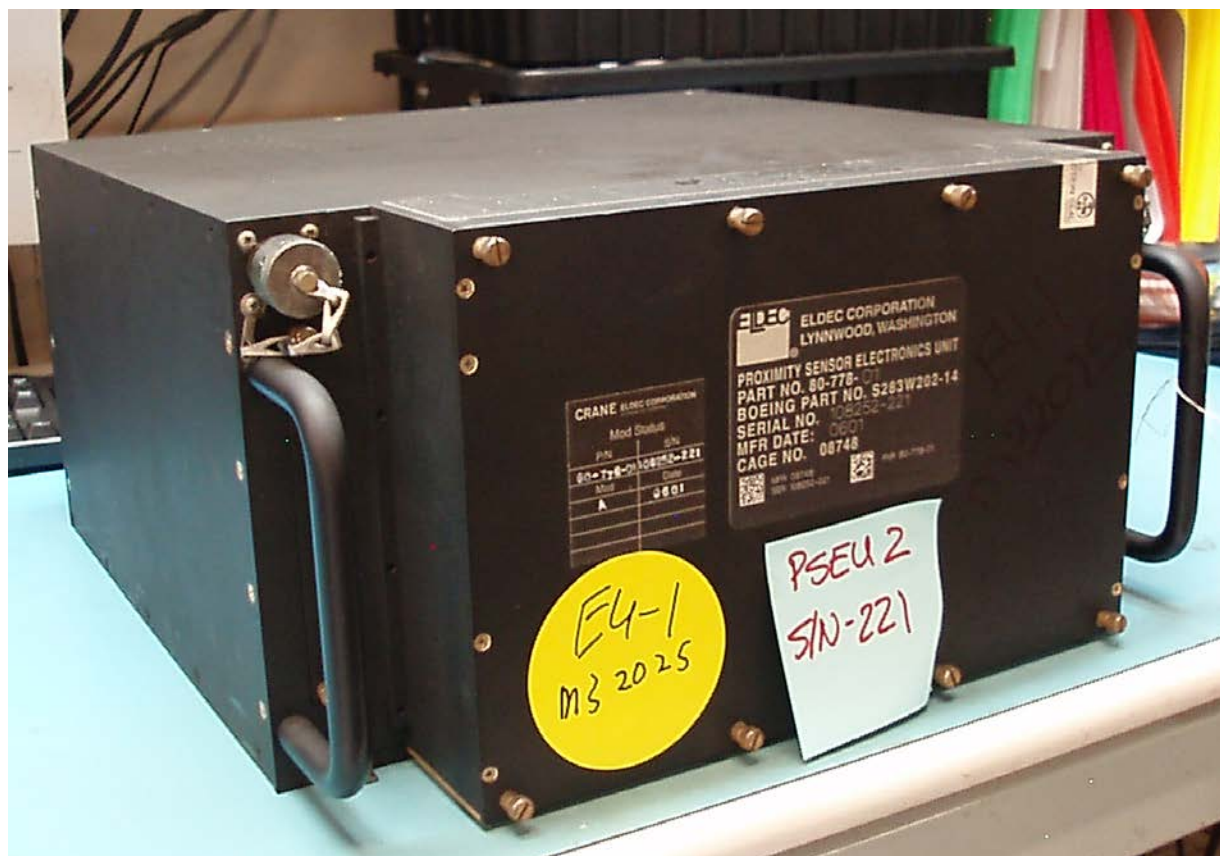
Figure 9: Proximity Sensor Electronics Unit

The PSEU was removed from a secure locker and removed from the packaging. A visual inspection was performed. Soot was identified on some areas of the unit's surface but the overall physical condition of the unit was good (see Figure 9). All cover screws were flush with the cover. All connector pins appeared straight and the tamper seals were intact. The unit did not appear to have any loose internal components. "E4-1 M32025" was the rack location that was written with marker on the side of the unit.
